Energy Report

2-Storey

Confirmed Insulation
2600 John St. #208
Markham, ON L3R 3W3

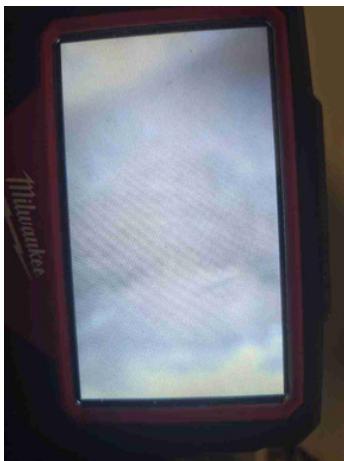
1.2 Item 1 (Picture) Exterior Walls – Inadequate insulation/air sealing

The Walls Are Fully Insulated Throughout The Home Except In The Basement. An Insulation Upgrade In This Area Is Not Cost-Effective At This Time, So No Changes Are Recommended.

Perform dense-pack insulation in exterior walls to increase insulation value and reduce energy loss.

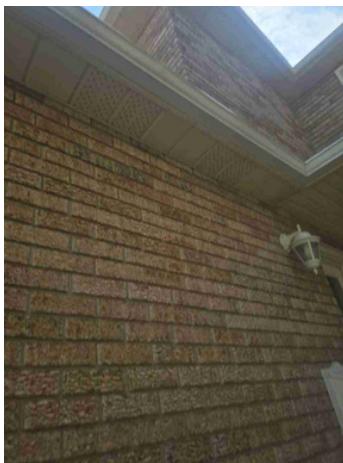
1.3 Item 1 (Picture) Soffits and Fascias – Damage restricting ventilation

The Soffit Vents Are Open And Functioning From The Exterior, Allowing Airflow Into The Attic.

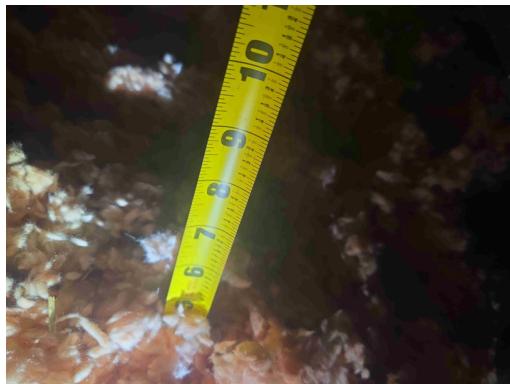
2.1 Item 1 (Picture) Attic Insulation – Low coverage/compression

Attic insulation levels vary, with low points of 4 inches and high points of 10 inches, which is well below current standards. Upgrading insulation to R60 (approximately 22 inches) is recommended to ensure consistent coverage, reduce energy loss, and improve year-round comfort.

- Add R-60 (22 inches) of blown-in fiberglass insulation to improve thermal performance and reduce heat loss.

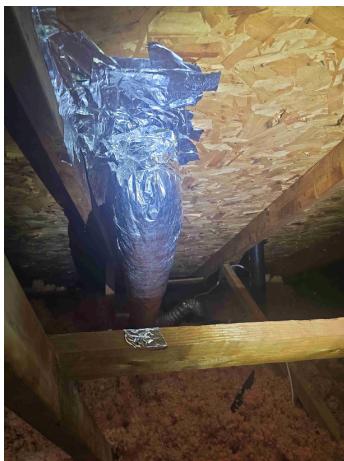
2.3 Item 1 (Picture) Exhaust Systems – Improper venting/moisture risk

The washroom fan is exhausting air but is not properly connected, as it is only placed beside a roof vent. It should be securely vented to the exterior through a proper roof fitting with a clamp to ensure effective moisture removal and to prevent condensation or mold issues in the attic.

- Properly connect all exhaust vents to discharge through the roof, preventing humidity buildup and reducing the risk of mold growth.

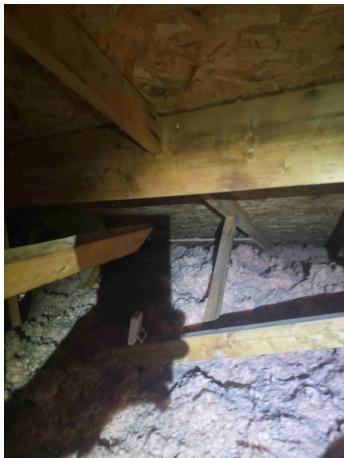
2.4 Roof Deck / Ventilation (Soffit & Ridge Vents, Baffles) Damage restricting ventilation

While the soffit vents are open, the attic feels exceptionally hot, indicating insufficient air movement. Installing a solar-powered attic fan is recommended to improve airflow, reduce heat buildup, and extend the life of roofing materials while enhancing overall energy efficiency.

- Install a solar fan to improve airflow and maintain balanced attic ventilation.

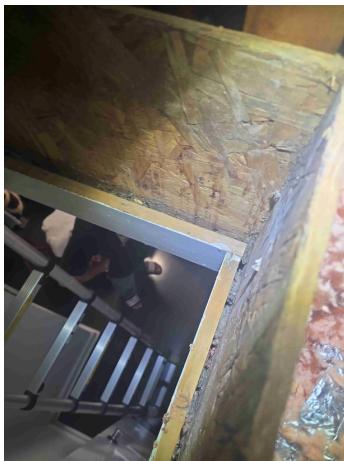
2.5 Item 1 (Picture) Attic Hatch/Access – Poor insulation/air leakage

The attic hatch requires a new seal and an extended wall to properly accommodate the upgraded insulation level. This will help prevent air leakage, maintain consistent insulation coverage, and improve overall energy efficiency.

- Add insulation to the attic hatch and install a weatherstrip seal to reduce air leakage at the access point.

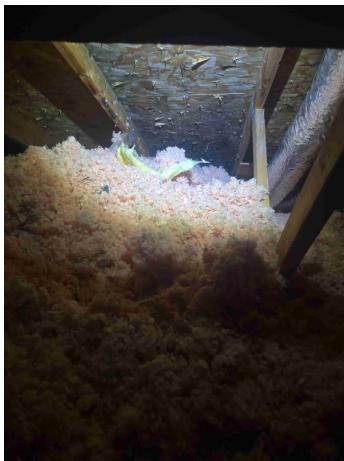
2.6 Item 1 (Picture) Moisture, Mold, or Pests - Visible staining or activity

Condensation is present in the attic, which can lead to mold growth. Remediation and improved ventilation/insulation are recommended to prevent future issues.

- Perform mold remediation treatment in the attic, including chemical application to stop active growth and removal of existing moisture/mold stains.

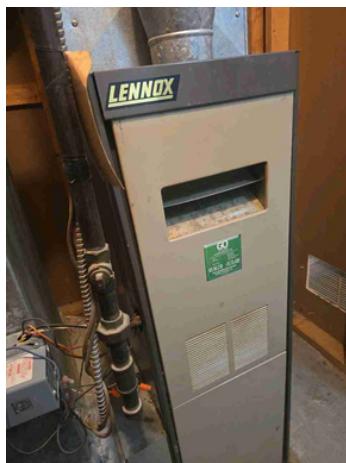
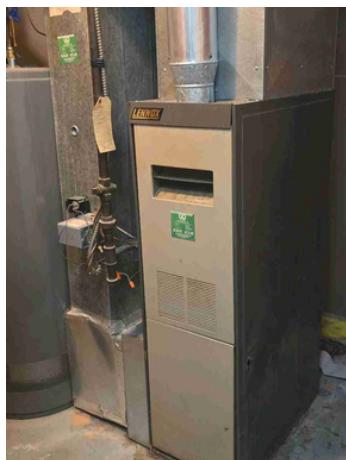
3.1 Item 1 (Picture) Furnace – Aging unit/low efficiency

The Existing Furnace Is A Lennox Unit Manufactured In 1996. It Has Significantly Aged Beyond Its Typical Service Life. Consider Replacing The Current Furnace With A High-Efficiency Model.

- Replace aging or inefficient furnace with a modern high-efficiency model to improve comfort, lower energy costs, and enhance reliability.

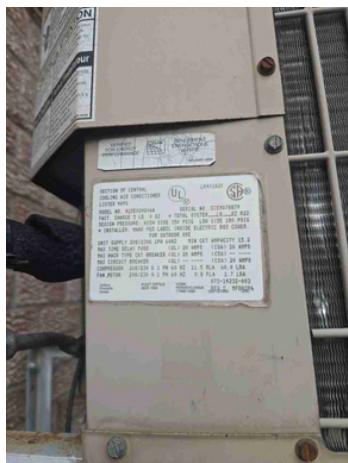
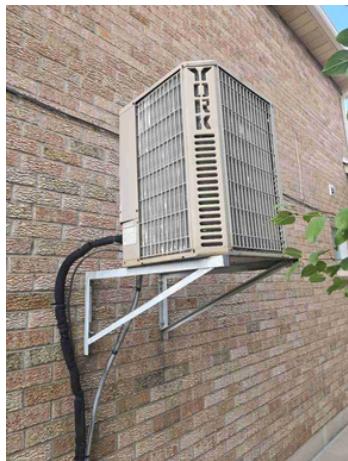
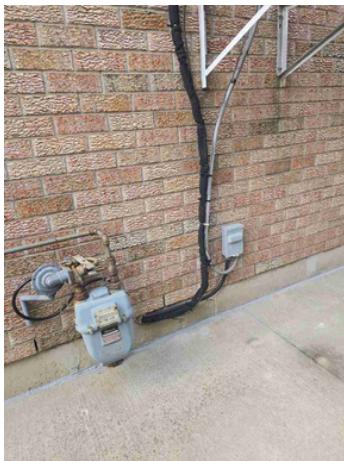
3.2 Item 1 (Picture) Air Conditioner – Reduced efficiency/service life

The Current York Ac System, Manufactured In 1996, Uses R22 Refrigerant, Which Is Obsolete And Costly To Service. Due To Its Age And Lower Efficiency, Replacement With A Modern Energy Star® Unit Is Recommended For Improved Reliability, Energy Savings, And Comfort.

- Upgrade existing air conditioning unit to a high-efficiency or heat pump system to reduce cooling costs, improve performance, and extend system lifespan.

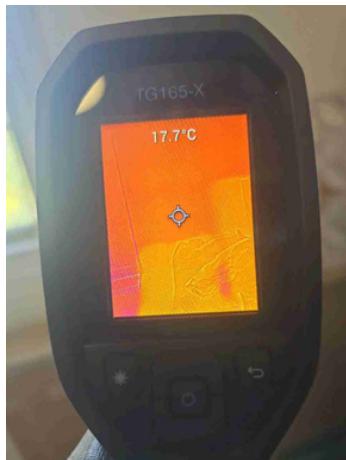
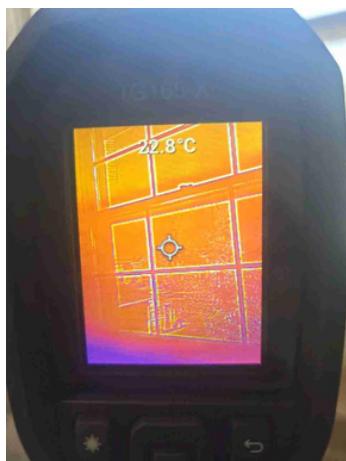
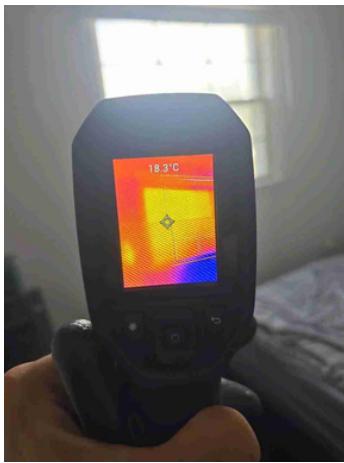
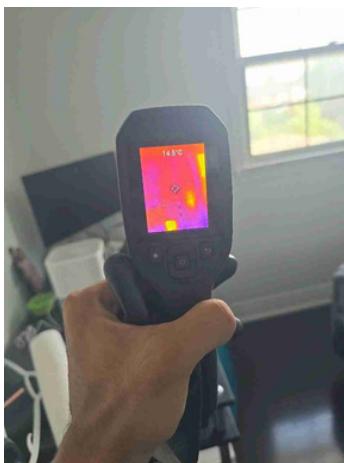
4.1 Item 1 (Picture) Windows – Poor seals/condensation risk

Thermal Imaging Shows Temperature Variations From 18.6°C To 31°C, Indicating Heat Loss In Winter And Heat Gain In Summer. The Original 1996 Windows Are Past Their Service Life; Upgrading To Energy Star® Double-Or Triple-Pane Units Is Recommended For Better Comfort And Efficiency.

- Replace existing windows with high-performance, energy-efficient models to reduce drafts, condensation, and energy costs.
